WYMAN POND DAM

MA 00641

**PHASE I INSPECTION REPORT
NATIONAL DAM INSPECTION PROGRAM**

AUGUST 1978

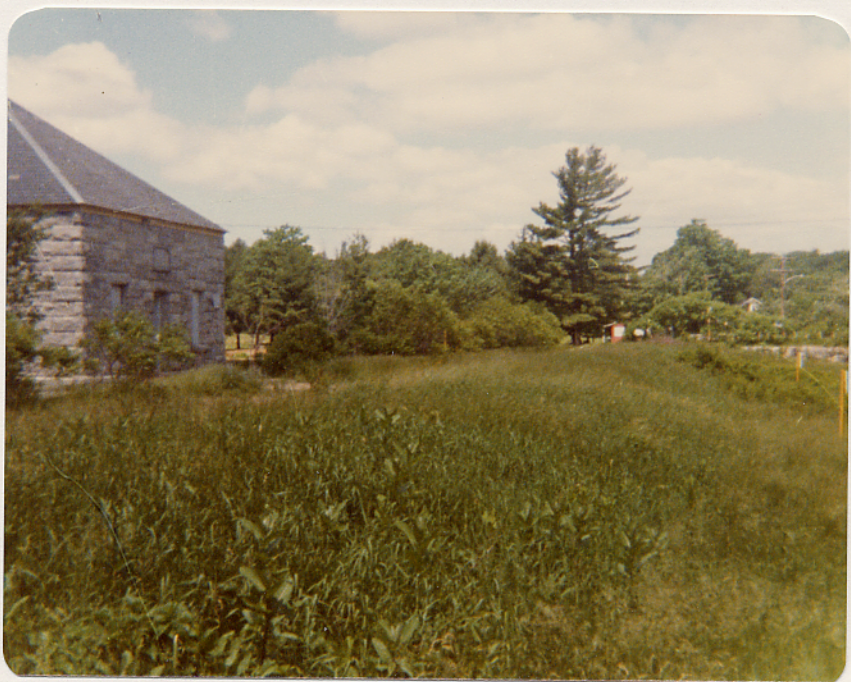
OVERVIEW PHOTO

b. Dam. The almost 80-year old Wyman Pond Dam appears to be in good condition. No significant vertical or horizontal misalignments were observed, nor were wet spots on the downstream surface. The dam is generally covered by low vegetation.
